**The Mountaineering Council of Scotland
Access & Conservation Committee**

**REPORT
BEINN A'BHEITHIR
CONSTRUCTED PATHS OUT OF GLEANN A' CHAOLAIS
By Mike Newbury**

I inspected the paths on 24 October, 2006 in dull conditions followed by heavy rain.

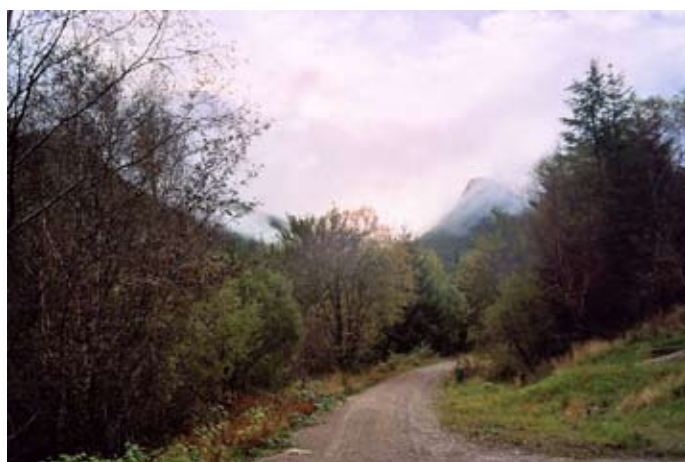
Fig. A1

The road makes a pleasant walk, with fringes of birch, alder and scrub willow softening the plantation edges (photo A1).

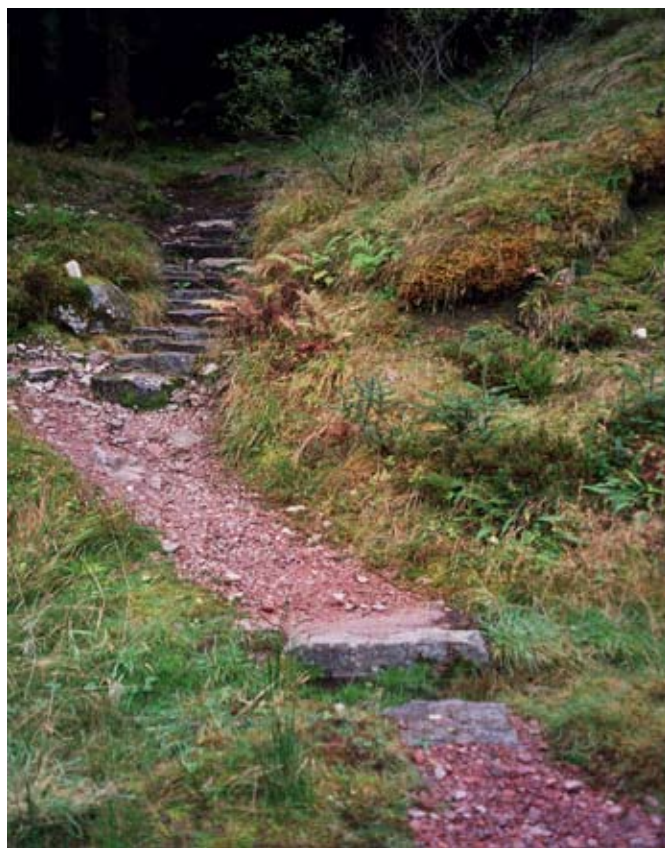
Fig. A2

The start of the path is part aggregate surfaced and part pitched (photo A2). The pitching is well built

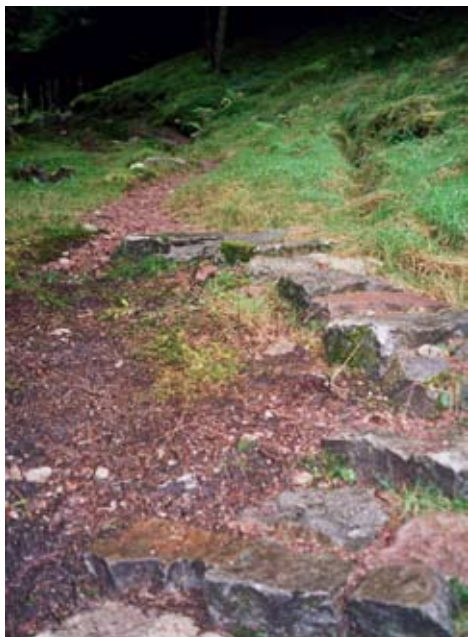
Fig. A3

(though rather step-like) with good foot placements but there is a design fault where it bends round some easy ground (photo A3), encouraging off-path use by downhill walkers, with consequent spillage of aggregate and erosion so that the stones will ‘grow’ as the ground sinks and become useless. A solution might be a blocking stone at the top and some brushwood on the slope.

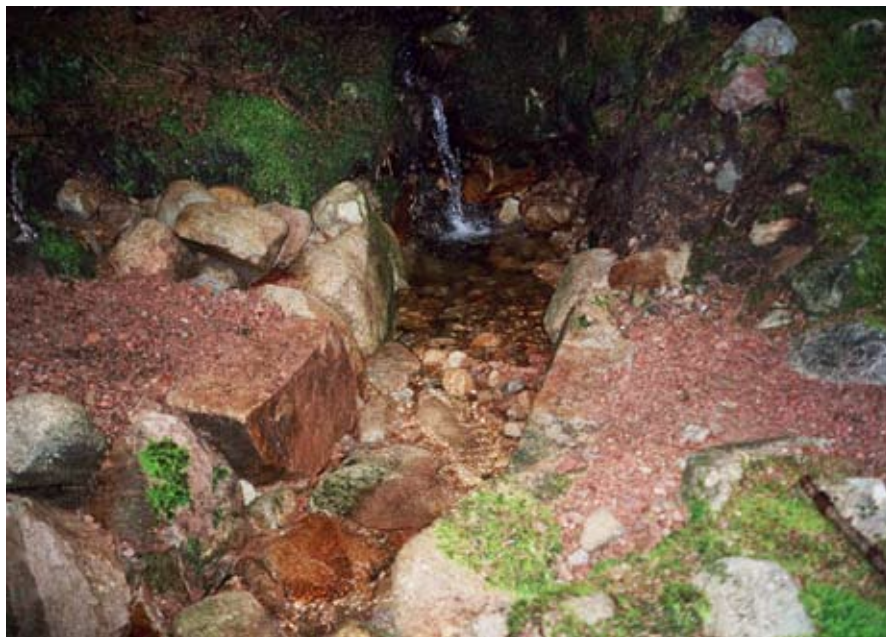
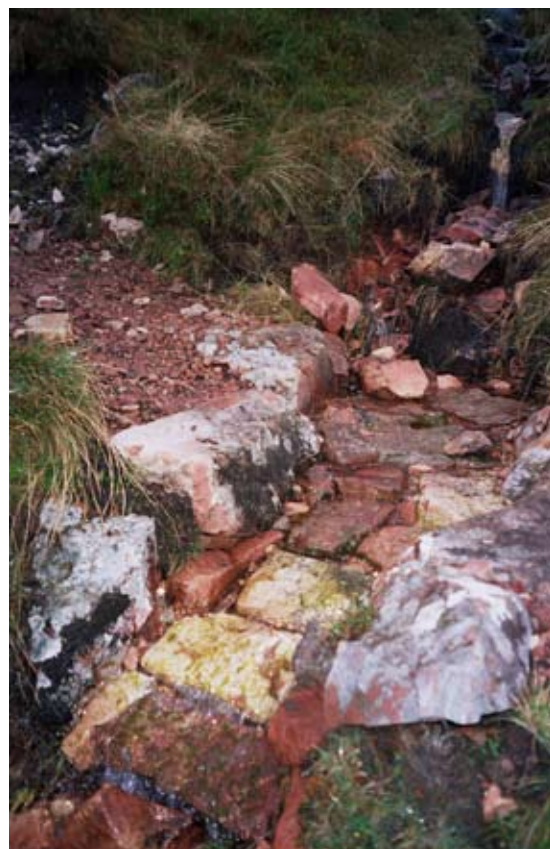
Stone-lined cross-drains (photo A4 & 17) are well-built.

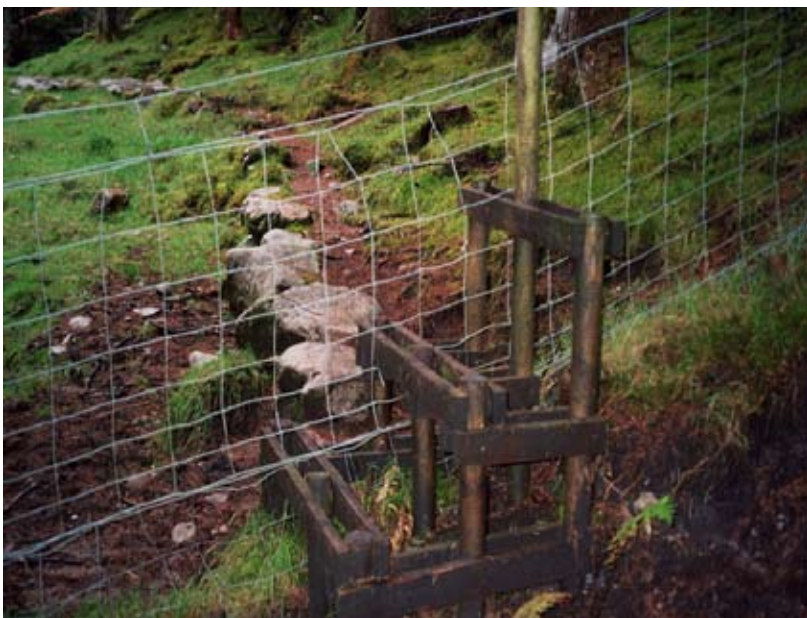
Fig. A5

There is a well-designed stile (photo A5) over an internal forestry fence 70m. along the path. A dog gate is needed in the mesh fence which FC have promised to install.

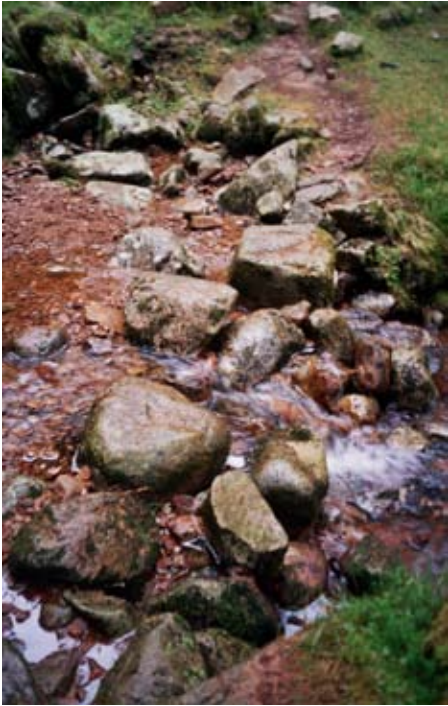
Fig. A6

A stream at about 130m. along is crossed by stepping-stones; these are green and rounded, and in my opinion, dangerous. (photo A6) They should be replaced by stones fit for purpose. It is easy to step on the gravel adjoining, but only when the water is low. The next stream also has an awkward crossing, involving a bank with a choice of sloping rock ledges or muddy pockets.

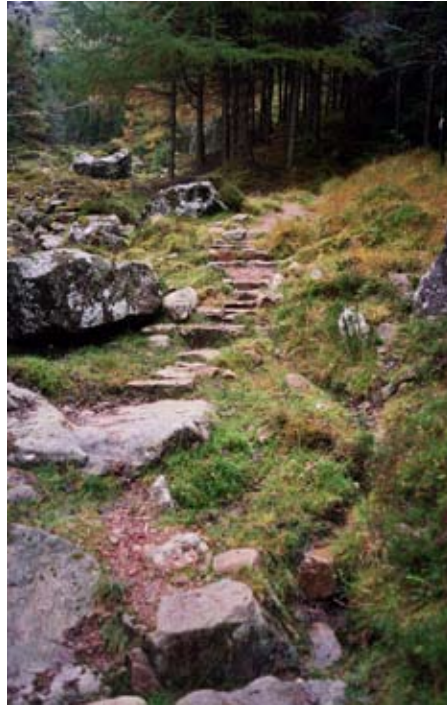
Fig. A7

The next section of path is well contained by turf and boulders (photo A7), but where it rises, the surface material is flowing over inadequate anchor-bars (photo A8). There is a short section following the top of an eroding slope where the blocks of stone look unstable in the long term and the sharp crest above is undermined and discharging material on to the path (photo A9).

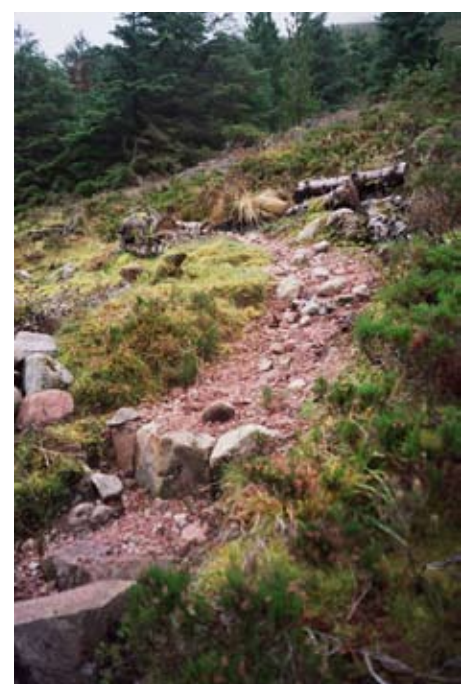
Fig. A12

A pleasant level section through larch trees follows (photo A10) and through open ground (photo A11), but where it rises there is movement of surface material flowing over anchor-bars, with loss of fines, and cobble stones appearing (photo A12).

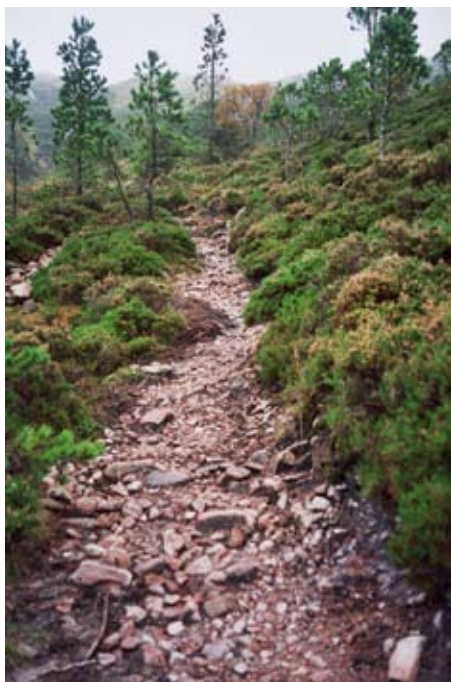
Fig. A13

A level section (Photo A13) is also rough, but well contained in deep heather.

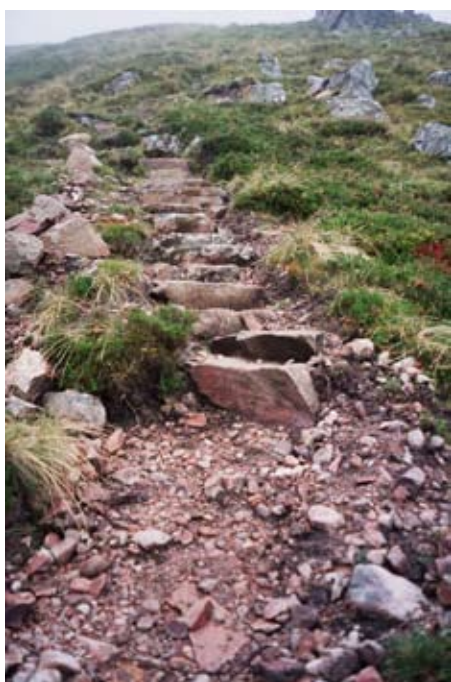
Fig. A16

Thereafter, the path rises out of the forest on a good line up a slight morainic ridge above the stream. It is partly pitched and partly aggregate surfaced. The pitching has good foot placements and is easy in descent as well as in ascent, but mostly lies within a ribbon of rubble, liable to erosion which could be aggravated by off-path use in descent as the ground here is more open. In my opinion, boulders, groups of large stones, turves etc. should be gathered, to landscape the path, contain path use, and most importantly stabilise the slope (photos A14-16) – but without robbing the adjoining ground! The aggregate sections are not holding well (see photo A16) – more anchor-bars and path containment is needed. Photo A20 shows a general downhill view.

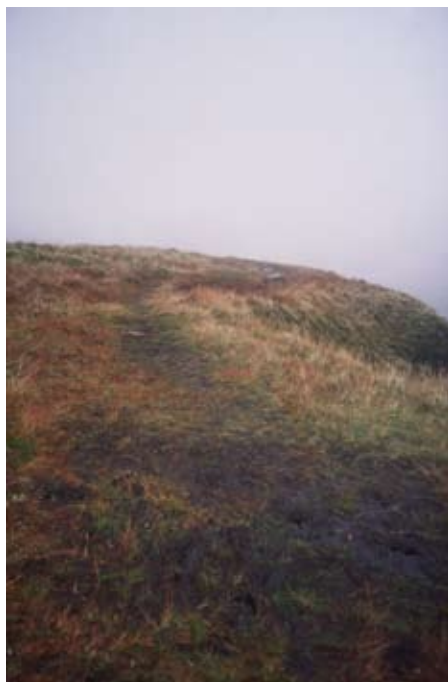
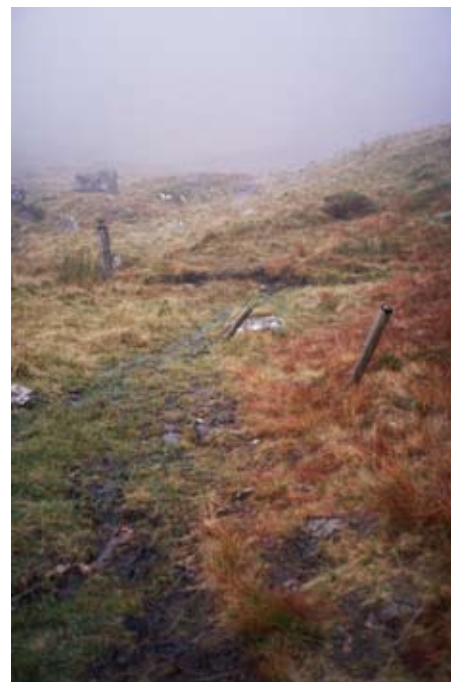
The last section to the boundary fence is unconstructed (photos A18-19). The turf is soggy in wet conditions, and would not take much wear. I consider that it should be monitored and some ditching installed if the turf begins to break up.

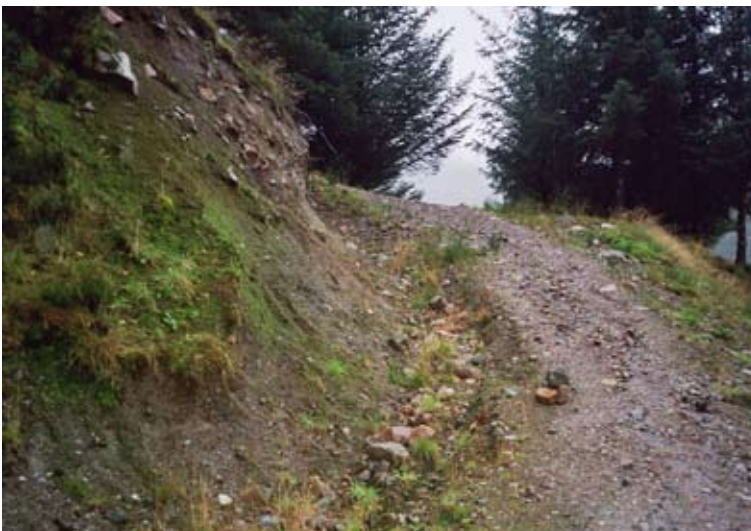
Fig. B1

The start of the path is excessively steep with an oversteep and unstable side slope above (photo B1). The rest of this section, which runs for about for about 400m. up to a forest road crossing, follows an easy gradient and the surface is beginning to vegetate. There is a good seepage ditch on the top side, and the verges and side slopes are well covered in turf (photo B2 – taken in heavy rain). Some channelled water-bars are needed (in this section through the lower forest) to take off surface water – I noticed rivulets beginning to form.

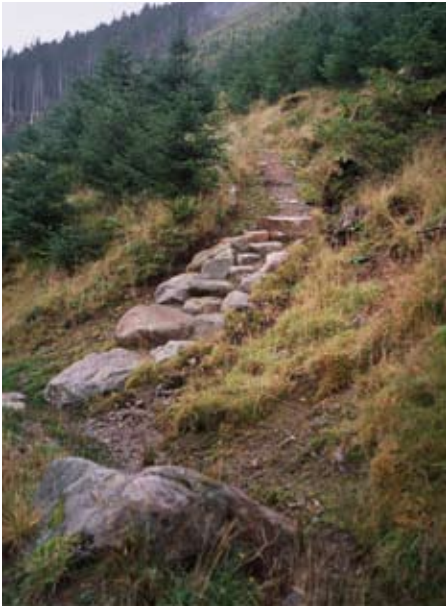
Fig. B3

From the road crossing the first 10m. has been pitched with huge boulders. A channel alongside needs block-ing or it will form a storm drain and erode (photo B3).

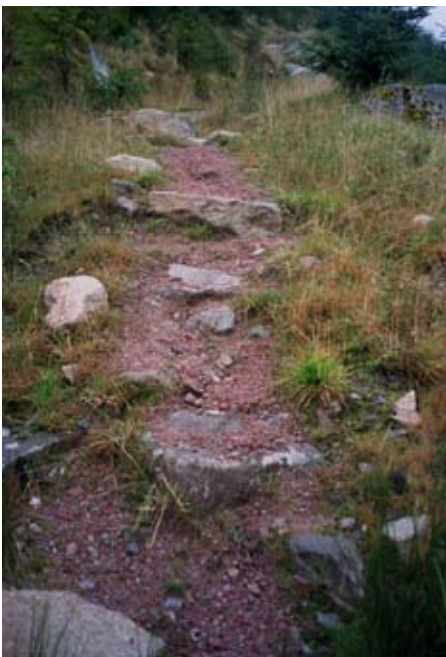
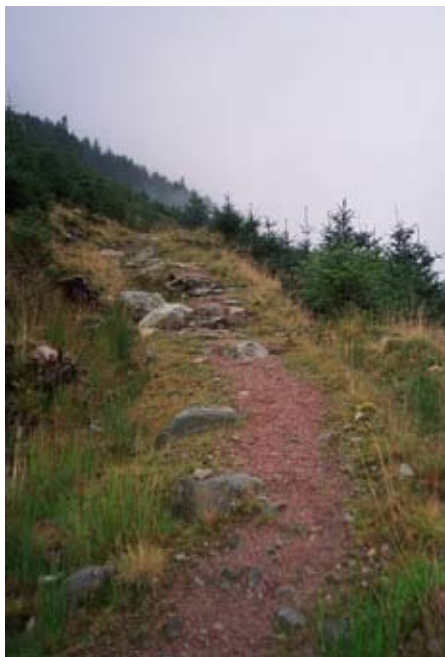
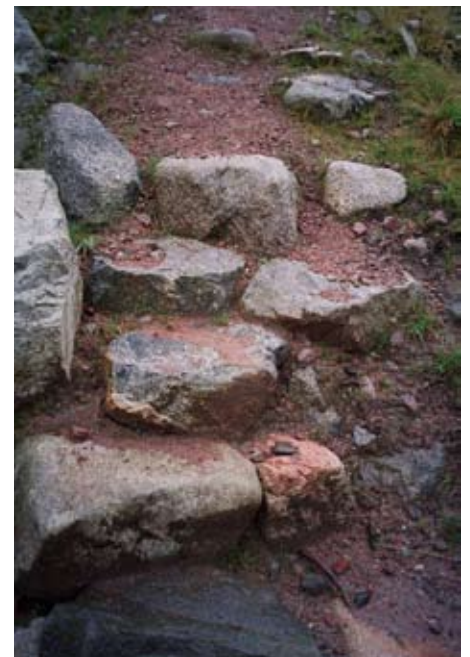
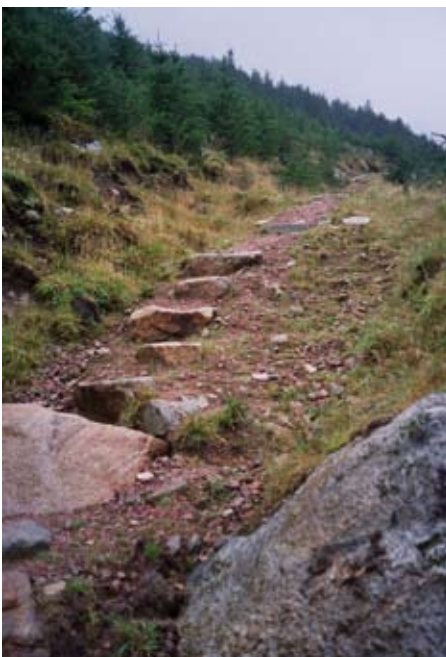
The path continues pleasantly at an easy gradient on a well-grassed bench (photos B4 & 5), but as soon as the gradient increases, problems arise: the gradient (up to 18 degrees) is too steep for the granular surfacing material, which is migrating downhill. Anchor-bars and a little pitching have been installed, but they are inadequate and material is flowing over and round the stones (photos B6 to 9).

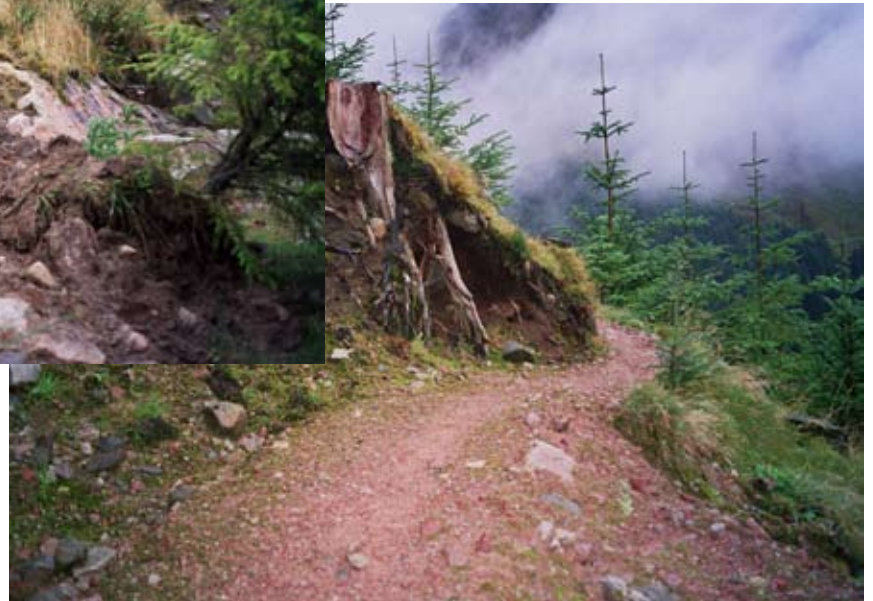
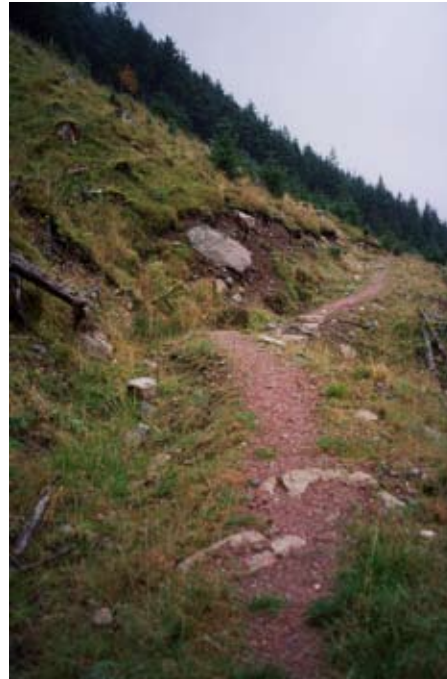
Continuing above the landslide, the path gradient eases and the path itself is good, but the side-slope above looks close to collapse and I would suggest a precautionary revetment (photos B12 & 13). The path, machine-built so far, then comes to the end of a long rising traverse of the steep hillside and is thereafter hand-built.

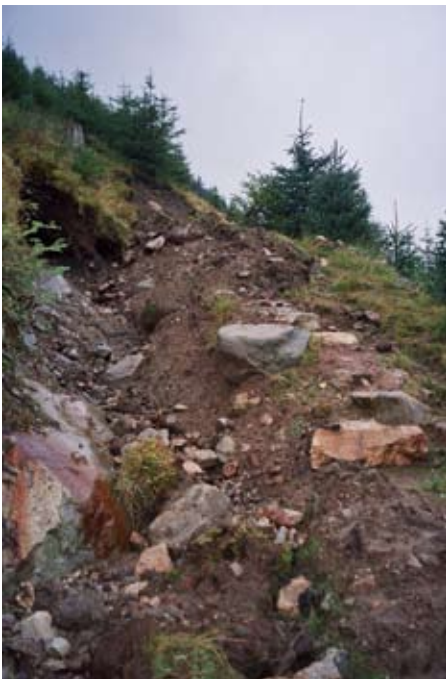
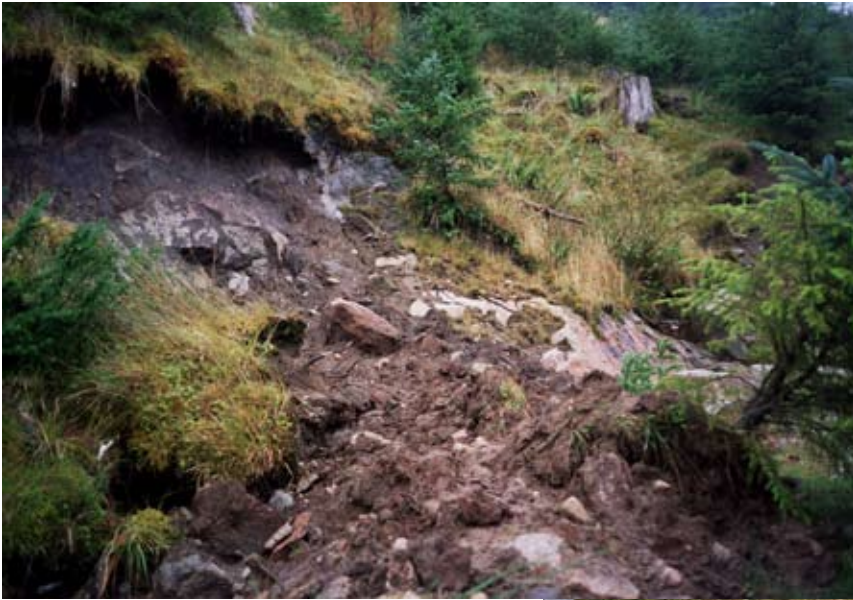
There follows a pathwork disaster: because of slumping of a wet over-steep side-slope above the path, earth and stones have fallen away,

engulfing the path (photos B10 & 11). The path here will have to be re-constructed and I can see no alternative for holding the side-slope except some form of revetment. Attempts to get away without it have failed.

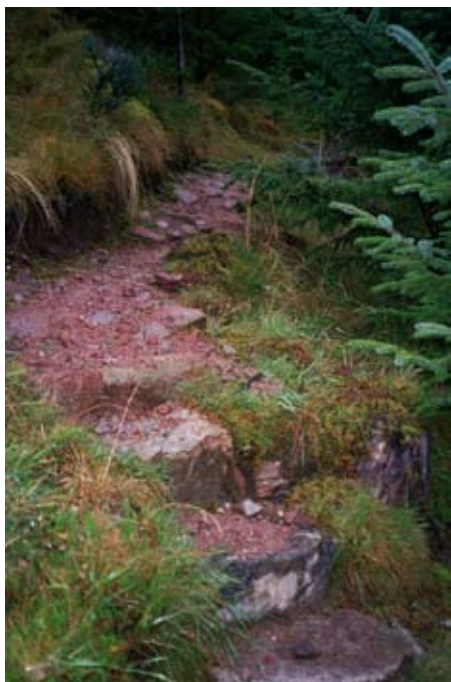
Fig. B14

A short section follows, rising and twisting up the hillside with stone steps and aggregate surfacing. The path here is narrow and precarious. I consider that more solidly placed anchor-bars are required (finish of this section shown in photo B14). The path continues on a near-level shelf into a dense plantation and is well built and contained (photos B15 & 16).
