**UPLAND PATH ADVISORY GROUP
SITE VISIT TO LOCHNAGAR
ON 13 JUNE 2007**

REPORT PUBLISHED BY THE MOUNTAINEERING COUNCIL OF SCOTLAND

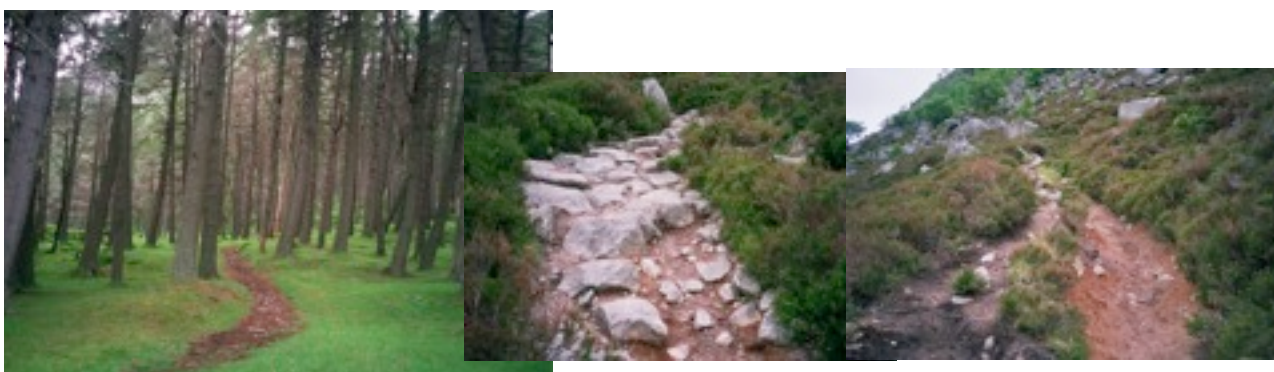
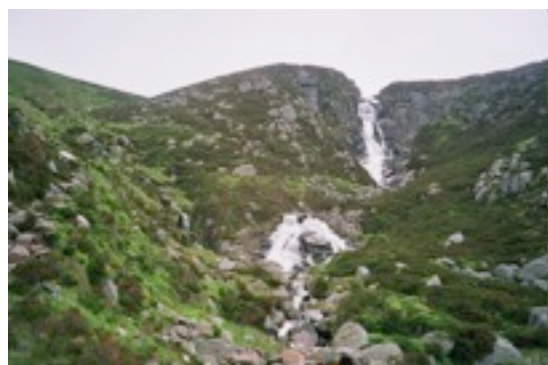
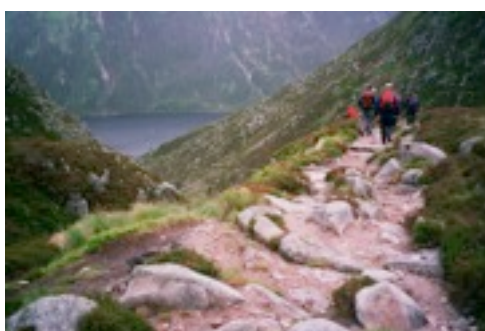
Photos
1 - 5

The path starts through a pine wood, and then by a zig-zag up a steep heathery slope. The path here is deeply grooved in places, and there is a little old failed pitching, but the erosion is well contained. (Photos 1-3) It continues along the steep left (facing) side of a gully where it is rough and rocky; then up past a spectacular waterfall (Photos 4 & 5) and along beside the stream with some boulder paving which is contained by a steep bank above and below. (Photo 6) Approaching the bridge, the path becomes cobbly, although almost level.

This whole section of path will be checked in course of an overall condition survey this summer for possible remedial work.

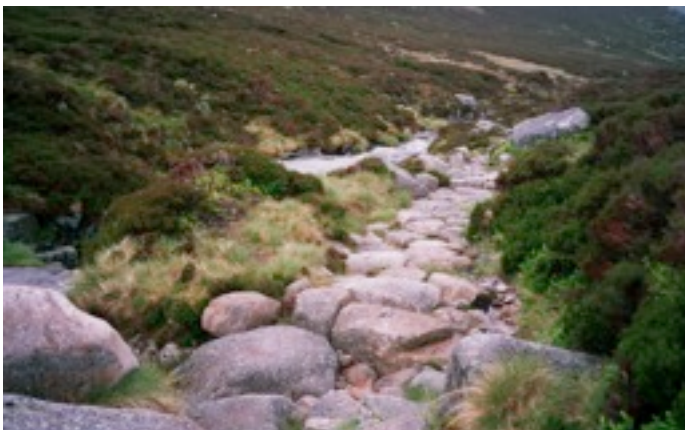
Photo 6

We were told that the loss of surfacing is caused by flooding, as the bridge with its concrete abutments forms a pinch point blocking the stream in spate, especially when it is choked with snow.

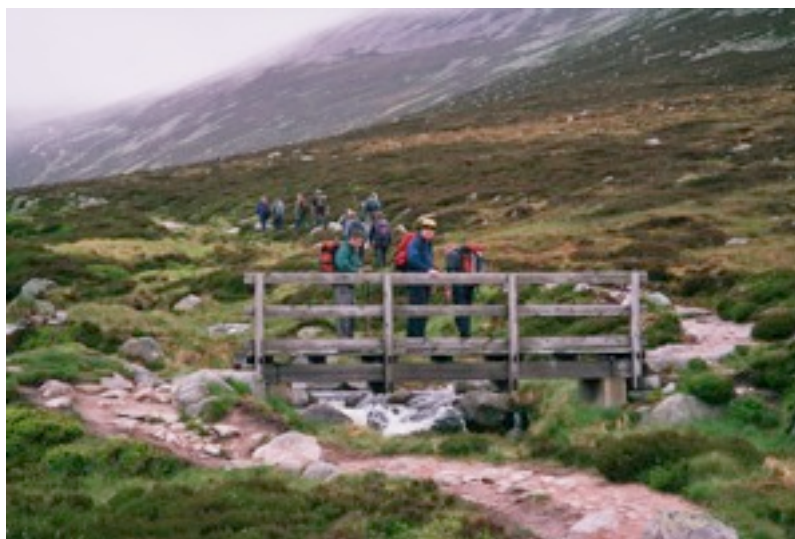
Photo 7

The bridge (Photo 7) is strongly built of timber on girders, with hand-rail, but looks out of place in the open surroundings. It is proposed to replace it upstream with large stepping-stones, possibly with slabs on top to form a clapper bridge, and remove the concrete abutments.

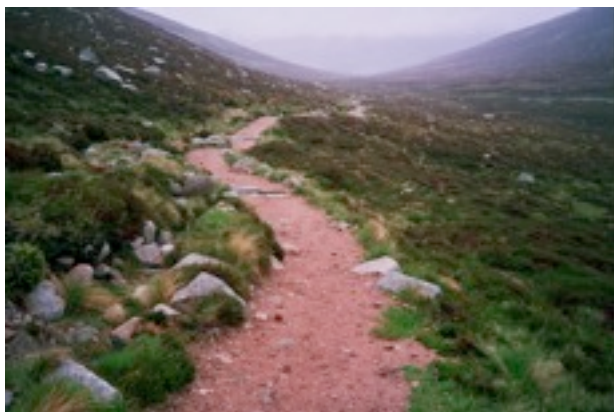
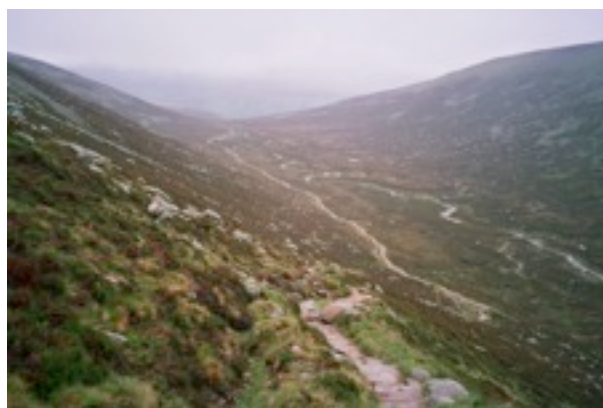
Photos 8 & 9 (looking back)

Continuing up the now gently sloping floor of the glen to right (true left) of the stream, a stalkers' path extending to approximately 1350 metres, was repaired in two phases in 1998 and 1999 by Highland Conservation Services Ltd. (Photos 8 & 9, both looking back)

Although surfaced with mobile granite grit, there does not appear to be significant loss of fines, maybe due to minimal gradient, moderate usage and good drainage. There are massive granite-lined cross drains. Although apparently stable, the path still shows up starkly from above and there is little colonisation by algae, mosses or dwarf grass. (Maybe a short stretch could be dressed experimentally with peat and fertiliser?)

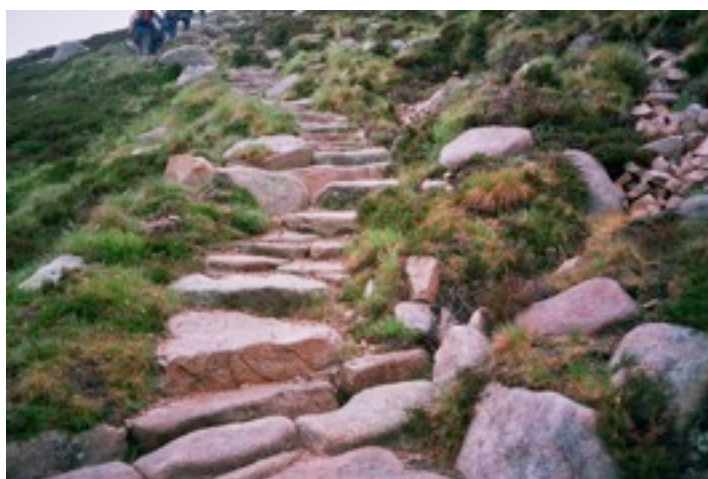
Photo 10

A pitched section follows, rising diagonally leftwards up the hill flank. This was built in 2000. The pitching is of massive slabs with good foot placements, a little stepped in appearance, but well contained and effective with no off-path wear apparent. (Photo 10)

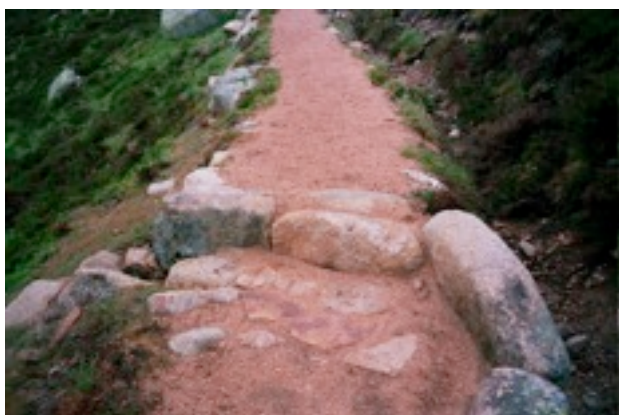
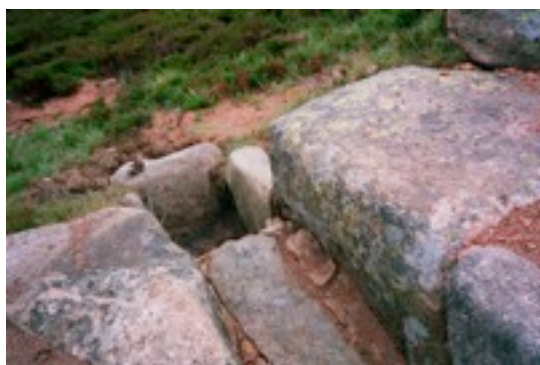
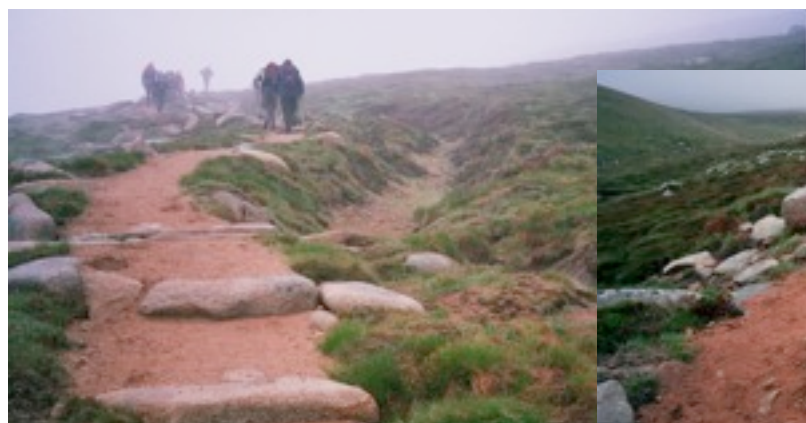
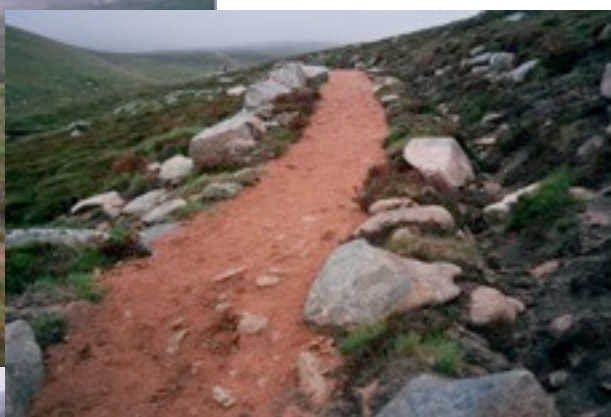
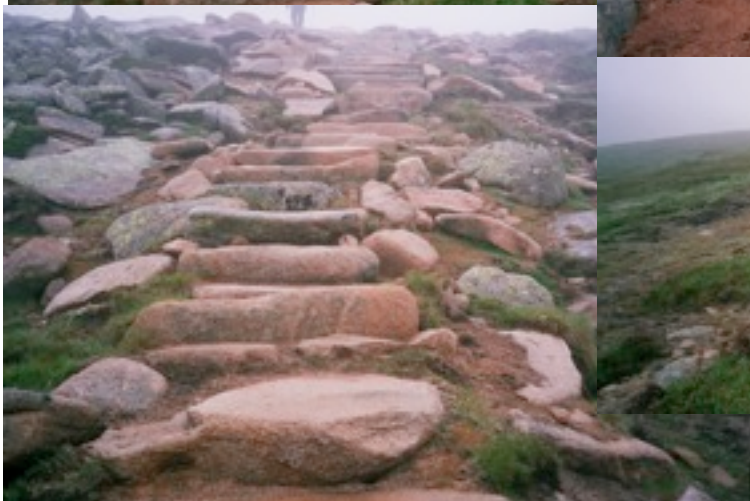
Photos 11 - 16

The path, described as 'stalker style', forms a raised semi-causeway rising leftwards across the hill flank with a continuous topside ditch providing the material which was taken out by machine and graded to fill the 1 metre wide path contained by a line of boulders on either side. (Photos 11 - 16) The surface material excavated was back-filled into the ditch which is wide and shallow and has been seeded with a fescue/bent grass mix with fertiliser (using Scotia Seeds special seed mix, Seed Aide mulch and Mascot Planting Plus low-nitrogen fertiliser). The ditch will normally take only seepage, but there are massive open

stone-lined cross drains, with voluminous stone-boxed letts for gathering silt. The upper edges of the ditch are over-steep in places, but maybe not high enough to matter.

There are two places near the start where some surfacing has moved, exposing larger stones, and it seems that the gradient, although only about 14 degrees at most, is too high without extra anchor bars for support.

Near the top of the path especially, anchor bars of massive boulder slabs cross the path. They are well contained on either side and in places there are several together forming a short stair. The risers are high and the effect may be too formal, but the work appears to be very functional.

underfoot, but because of the raised surface and the steep slopes above and below, path avoidance would be much more difficult than on the main path. Maintenance should include not only the return of material out of the drains, but also topping up with surfacing material from other sources.

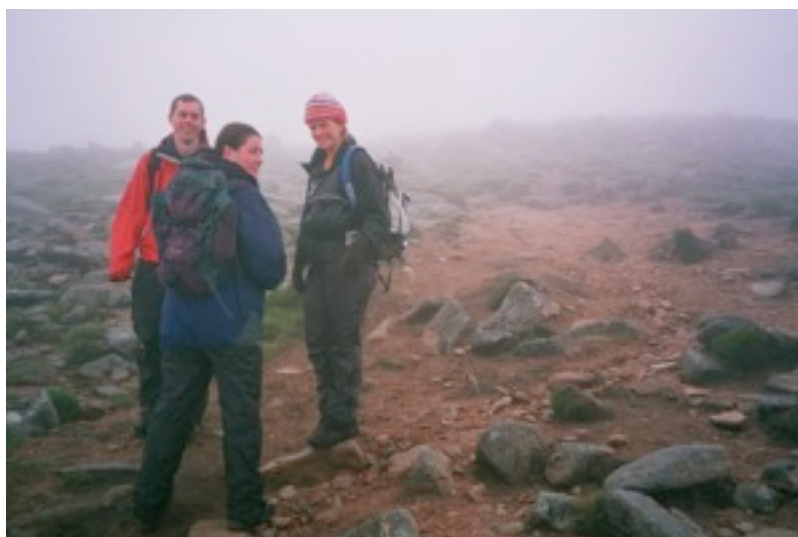
Photo 17

From the junction at the top of the new pathwork, we turned east on a good natural path converging with the edge of the big north-facing corrie, then north-east close to the edge, on a near-level area of natural granite paving. There is some wear of the ground between the stones here, but the short turf is mostly persisting. However, as the slope down to north-east increases, we came on to a wide erosion scar of about 100 metres which is apparently active and needing early treatment. Then came the top of fresh pathwork forming the rebuilt Ladder Path, and it became obvious to the whole party that this is where the money ran out. (Photo 17)

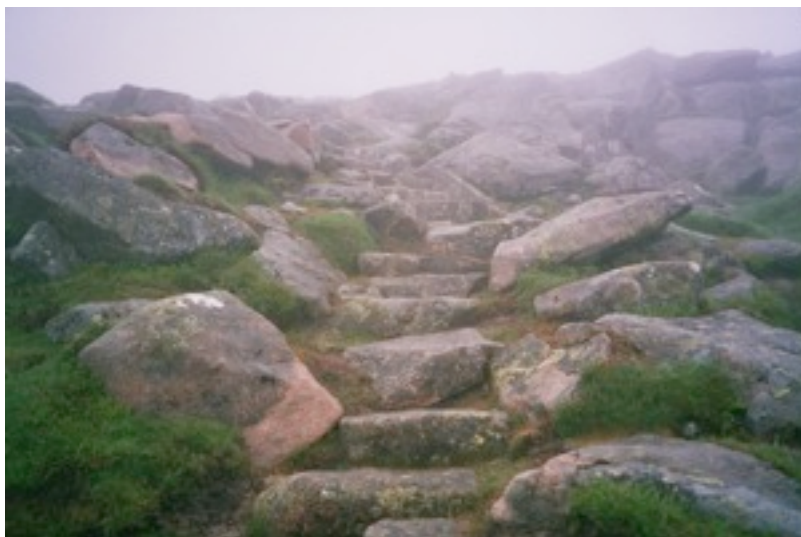
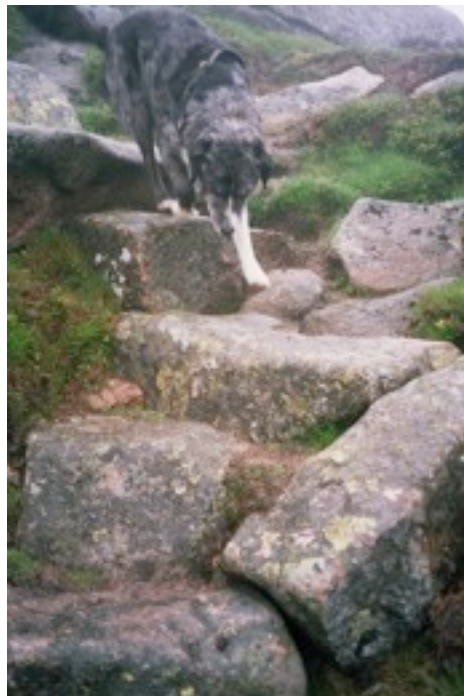
Photos 18 & 19

The solution adopted was to form a single ascent/descent route winding up the steep massive boulder scree close to the rim and merging into pitching comprised of large slabs above and below. It was discovered that the blocks could not be readily moved around for this purpose because of the huge voids below, so blocks of similar granite were brought in by helicopter in bags, and deposited near the chosen line, whence they were winched into place. (Photos 18 & 19)

This we found to be a varied and entertaining descent with little perception of artificiality. The construction is stable, sensitively executed and should not require much maintenance. The old Ladder Path has been blocked off and the erosion scar spot-turfed and re-seeded (using Scotia Seeds special seed mix, Seed Aide mulch and Mascot Planting Plus low-nitrogen fertiliser) As far as could be seen in the mist, this is completely successful and there is only one short length of incipient off-path use, which will be dealt with.

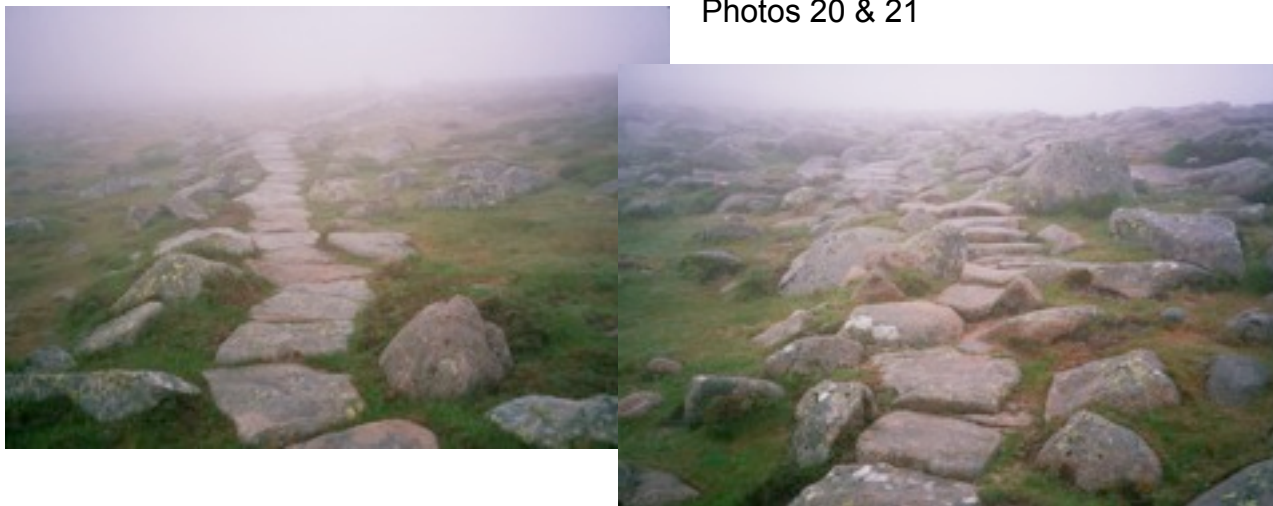
Photos 20 & 21

These fears appear to have proved false in the event. The slabs are large, near level and close together, forming an excellent walking surface with the edge stones preventing edge wear, and it seems there has been no temptation to step over them as the turf on either side is unworn and in excellent condition. Of course, some will object: walkers may prefer treading on a natural mountain, but their numbers have led to degradation, and the slabs are less obtrusive than a landscape scar, or in the writer's view, than most aggregate surfaced paths in the Cairngorms. (Photos 20 & 21)

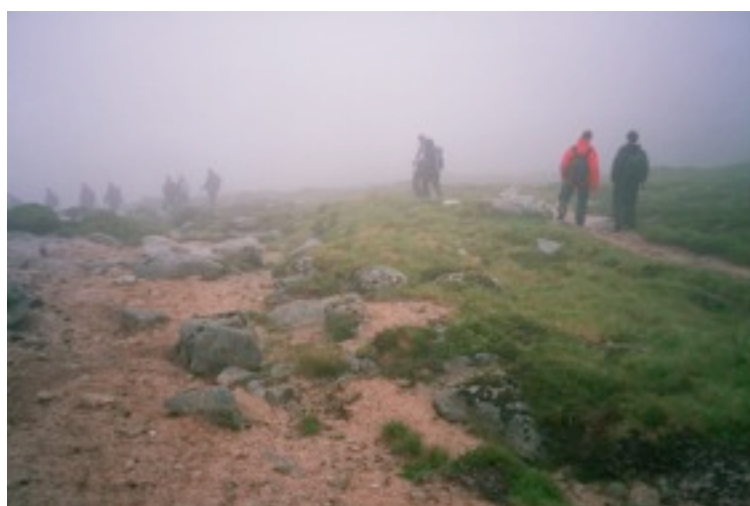
Photo 22

Starting at the lip of the bealach, the big erosion scar (Photo 22) on the left seems to have recovered a little, because no doubt the slab path delivers walkers right on to the unfriendly pitching so that it cannot be missed; but below this, the erosion is worse. The 2005 report says:

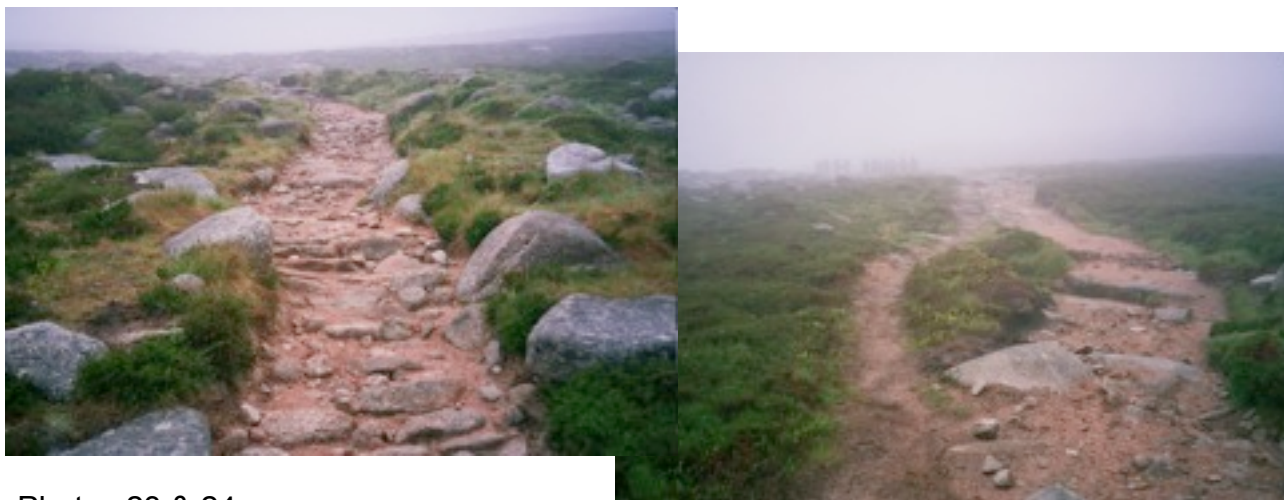
Photos 23 & 24

Now there seem to be hardly any user-friendly sections, and the braiding and diversions are worse. (Photos 23 & 24)

As already noted, this is an important main route, and in the writer's opinion, deterioration has reached the point when major reconstruction is required, and this work is second in urgency only to the 100 metres at the top of the Ladder. The alignment and cross drains are good. How a new construction should be built is problematical – some short sections of user-friendly pitching would be required; but even with copious anchor bars, there would be maintenance problems and containment problems with aggregate surfacing, and this points in the writer's view to at least some boulder slab paving!
