**The Mountaineering Council of Scotland
Access & Conservation Committee**

**REPORT
BEINN A'BHEITHIR
CONSTRUCTED PATHS OUT OF GLEANN A' CHAOLAIS
By Mike Newbury**

I inspected the paths on 24 October, 2006 in dull conditions followed by heavy rain.

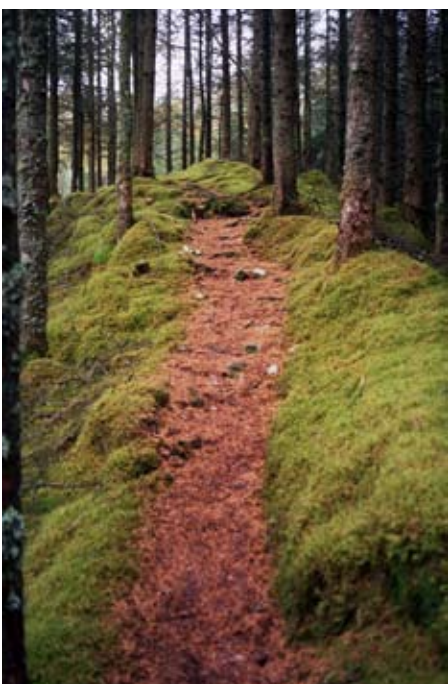
Fig. A10

A pleasant level section through larch trees follows (photo A10) and through open ground (photo A11), but where it rises there is movement of surface material flowing over anchor-bars, with loss of fines, and cobble stones appearing (photo A12).

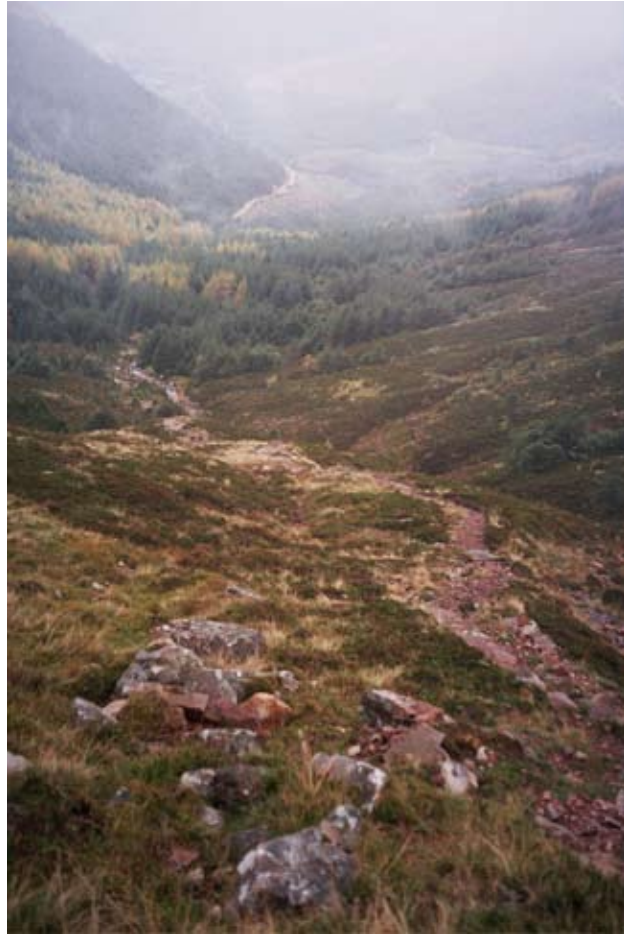
Fig. A20

Thereafter, the path rises out of the forest on a good line up a slight morainic ridge above the stream. It is partly pitched and partly aggregate surfaced. The pitching has good foot placements and is easy in descent as well as in ascent, but mostly lies within a ribbon of rubble, liable to erosion which could be aggravated by off-path use in descent as the ground here is more open. In my opinion, boulders, groups of large stones, turves etc. should be gathered, to landscape the path, contain path use, and most importantly stabilise the slope (photos A14-16) – but without robbing the adjoining ground! The aggregate sections are not holding well (see photo A16) – more anchor-bars and path containment is needed. Photo A20 shows a general downhill view.

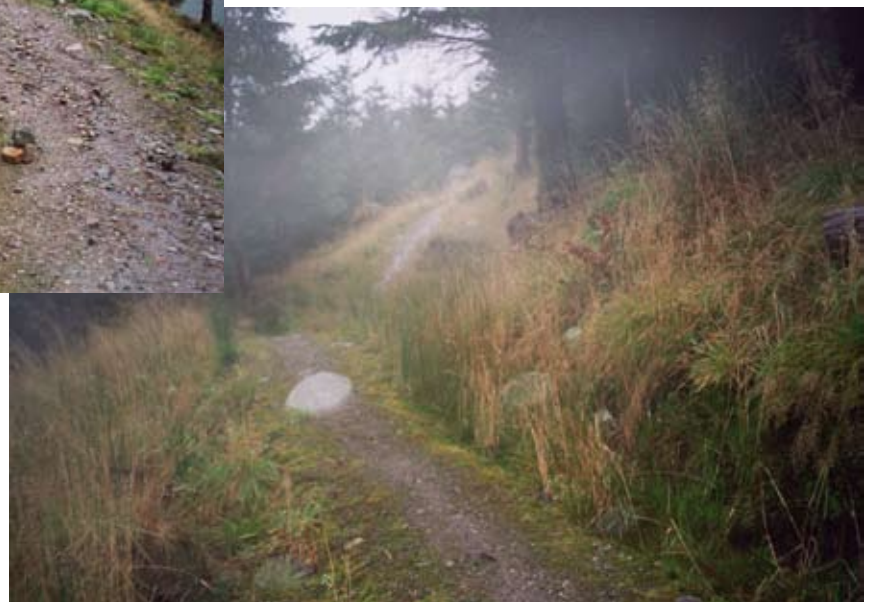
Fig. B2

The start of the path is excessively steep with an oversteep and unstable side slope above (photo B1). The rest of this section, which runs for about for about 400m. up to a forest road crossing, follows an easy gradient and the surface is beginning to vegetate. There is a good seepage ditch on the top side, and the verges and side slopes are well covered in turf (photo B2 – taken in heavy rain). Some channelled water-bars are needed (in this section through the lower forest) to take off surface water – I noticed rivulets beginning to form.

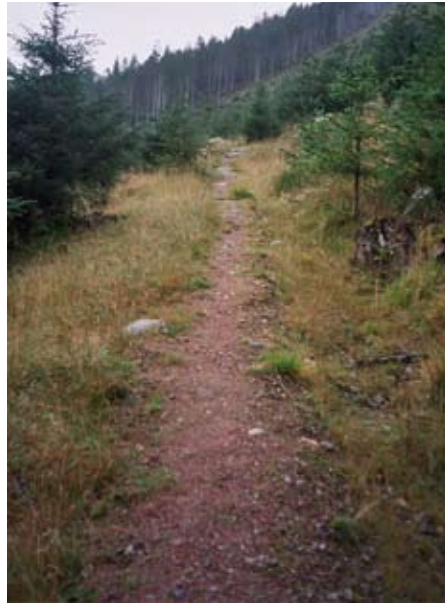
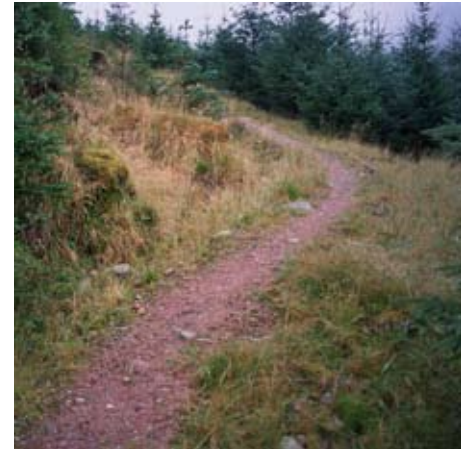
The path continues pleasantly at an easy gradient on a well-grassed bench (photos B4 & 5), but as soon as the gradient increases, problems arise: the gradient (up to 18 degrees) is too steep for the granular surfacing material, which is migrating downhill. Anchor-bars and a little pitching have been installed, but they are inadequate and material is flowing over and round the stones (photos B6 to 9).

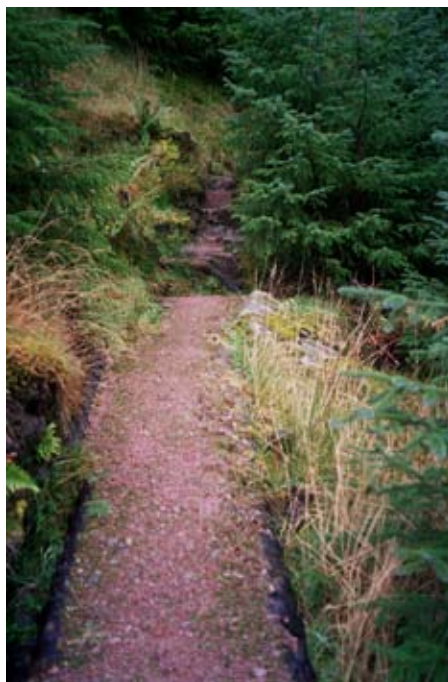
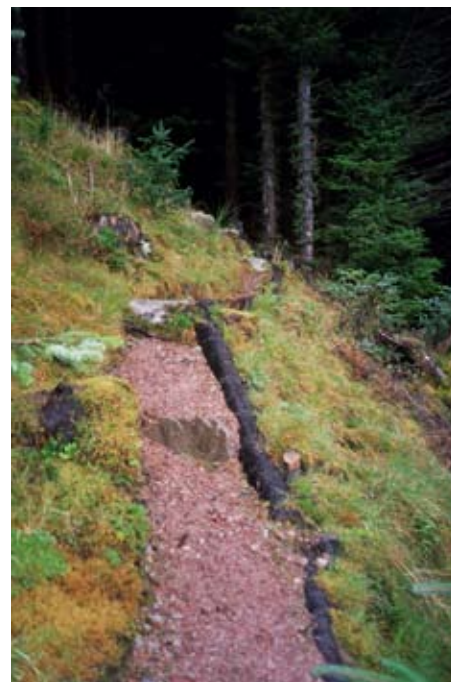
A short section follows, rising and twisting up the hillside with stone steps and aggregate surfacing. The path here is narrow and precarious. I consider that more solidly placed anchor-bars are required (finish of this section shown in photo B14). The path continues on a near-level shelf into a dense plantation and is well built and contained (photos B15 & 16).
