UPLAND PATH ADVISORY GROUP

SITE VISIT TO GLENMORE ON 1 SEPTEMBER 2008

Meall a'Bhuachaille

The Allt Mor Path

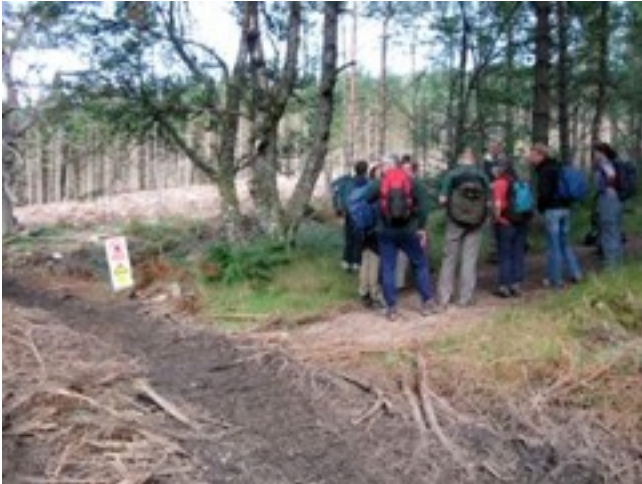
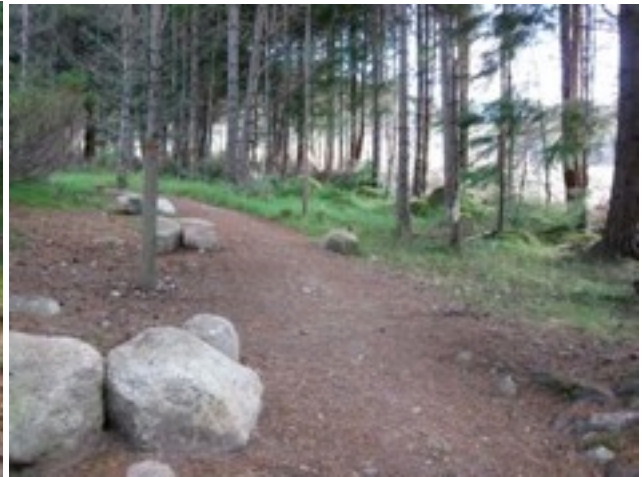
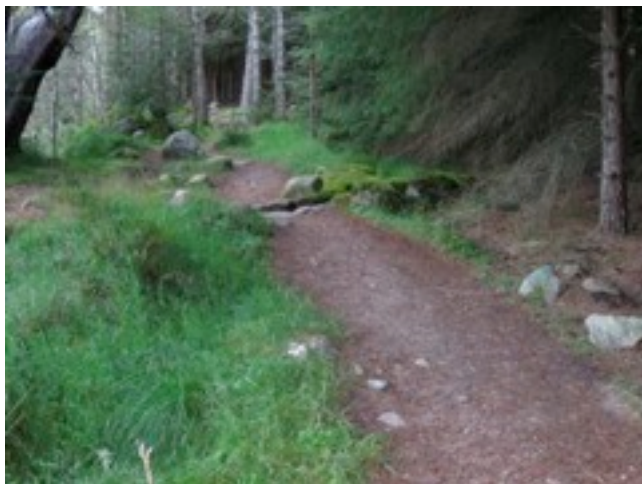
The path crosses an area being clear felled. It is understood that a major path diversion had been proposed for this operation, but FCS considered that it would be difficult to deflect walkers, so arrangements were made to manage access. The timber is felled away from the route on either side, with a controlled crossing point; the trees along the path are cut in the very early morning. These arrangements appear to work very well and FCS are to be congratulated. The cleared forest will be left for 2 years, then re-planted with Scots pine plus some larch, a little spruce (for wildlife diversity) and native deciduous trees.

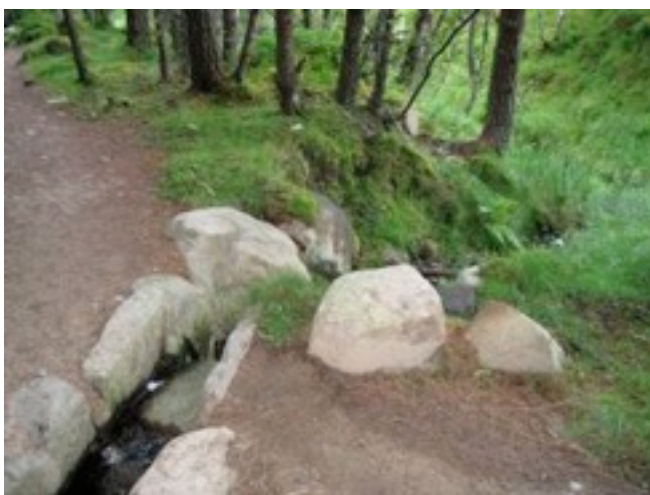
The new path follows the original line beside the Allt Coire Chondliach through the forest for about 1.3km. A diversion over a bridge and up further west was abandoned as it was roughly bulldozed in the 1970's on the fall line and formed an overflow torrent bed. Remnants of the old path close by the stream show that it was wet and bouldery and the new path through the forest is largely built up using some 200 tons of material extracted from a borrow pit immediately above the forest edge. The surface of the path is generally smooth with no washout of fines: it is at low gradient and the material is of schist type, which binds well.

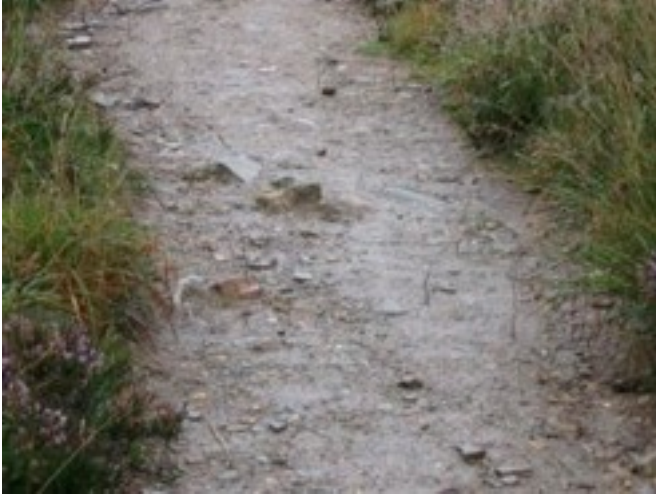
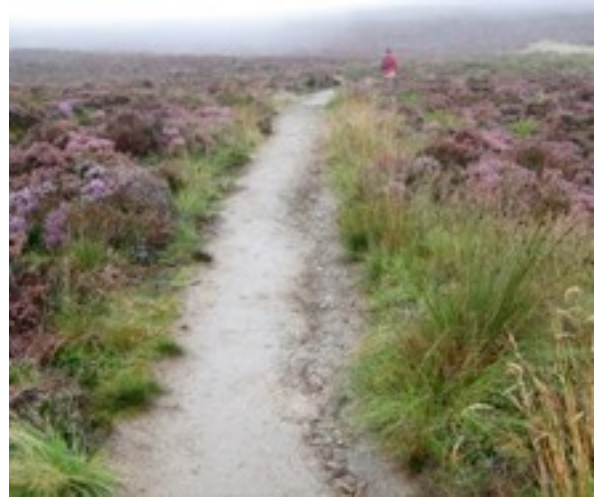
The open Coire Chondlaich into which the path emerges, is wet and peaty, and the path was notoriously mired. The route was changed to a more sustainable line. The new path is built up, with very effective cross-drains, and the side ditches dished and grass seeded so as to be less intrusive and to control erosion.

However, as the gradient increases to about 15 degrees there are some signs of loss of finer material from the surface, with loose and upstanding stones, and some incipient gullying where the water has run down

the path surface. Some additional anchor bars and water bars are required; and in common with nearly all sloping paths in the area, surface topping will be required to make up for loss of fines. This is a common occurrence on most hill paths in recent years which is exacerbated by increased heavy summer rainfall. Perhaps this might be addressed in future design/construction of hill paths in general through adequate anchor bars and improved surface drainage.

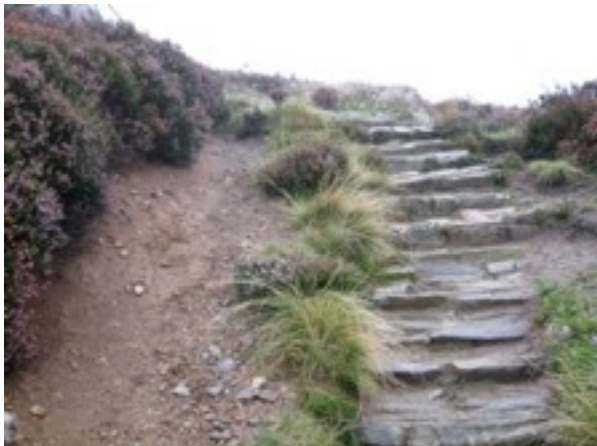
The first section of pitching extending to about 30m. was built earlier, in 1998, by a NTS training team, in the style then prevailing – ridged and sloping and treacherous in descent. The top of this pitching is quite steep and has been avoided to produce a gully with overhanging heather on one side and the stonework of the path standing high on the other. Remedial work is required here.

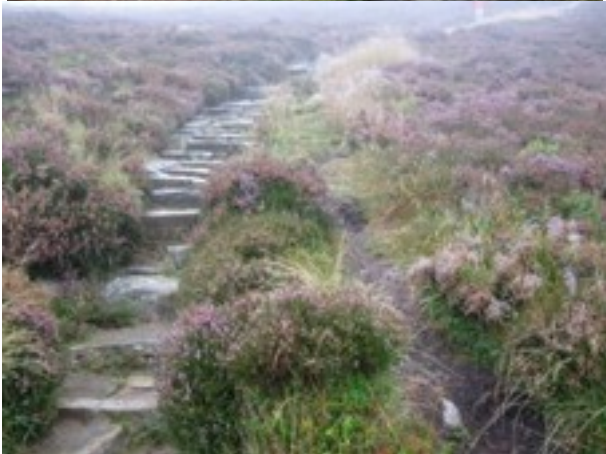
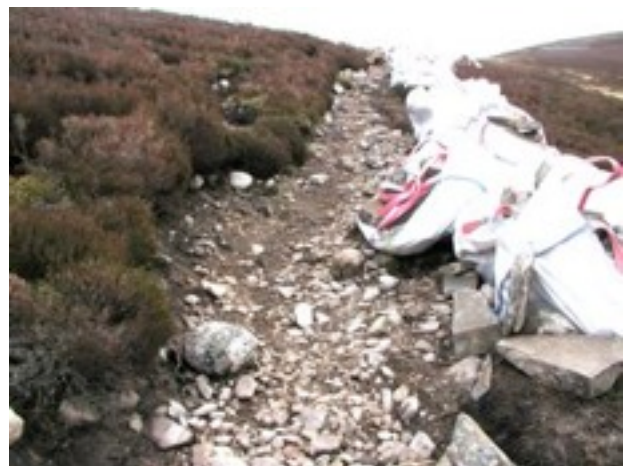
Path under construction - photo Jim Gillies

The rest of the pitching throughout the whole route is all of recent construction and excellent. The material was gathered on the same hill and brought in by helicopter. It is of schist, forming square cut slabs. These are set on edge, generally in groups of twos and threes, to form adequate treads. An incipient diversion threatens to by-pass a section.

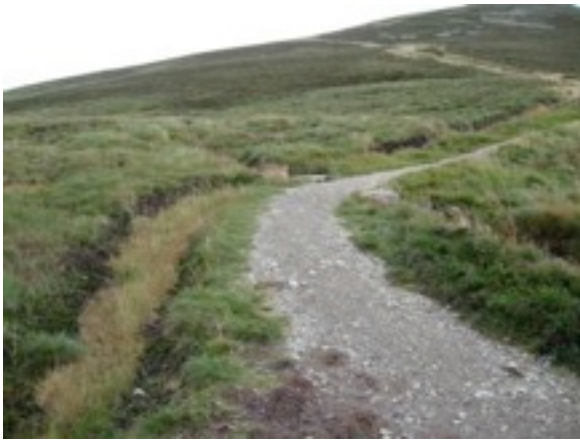
The path continues to the saddle between Creagan Gorm and Meall a'Bhuachaille, with locally won aggregate surfacing at moderate gradients and short sections of pitching. It is well contained in robust turf and heather. The dished grass-grown side drains are a notable feature.

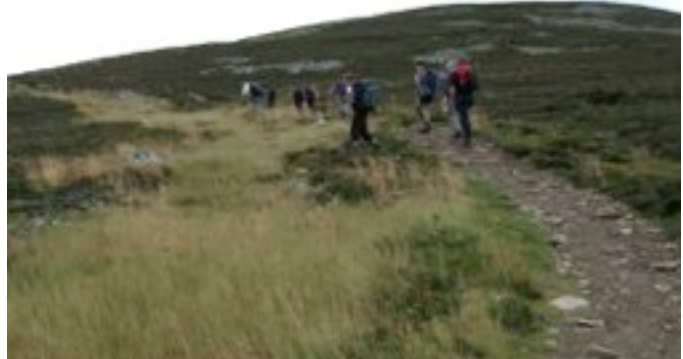
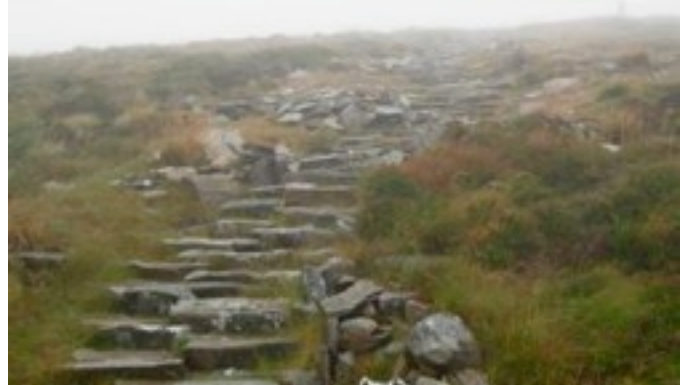
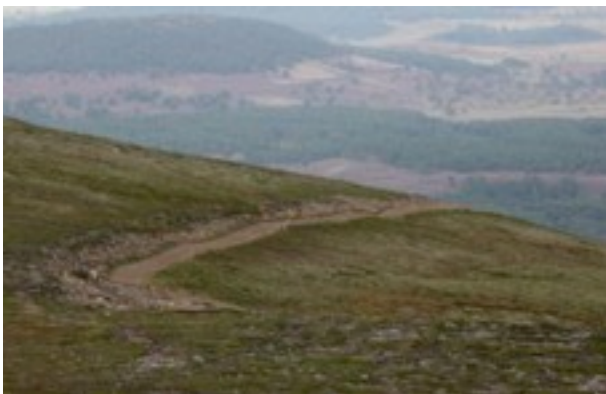
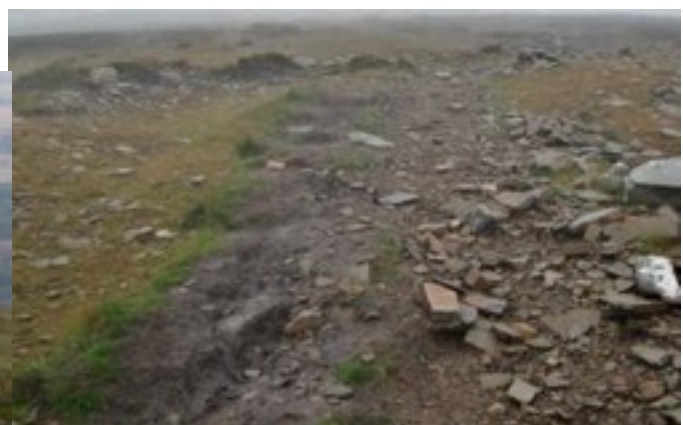
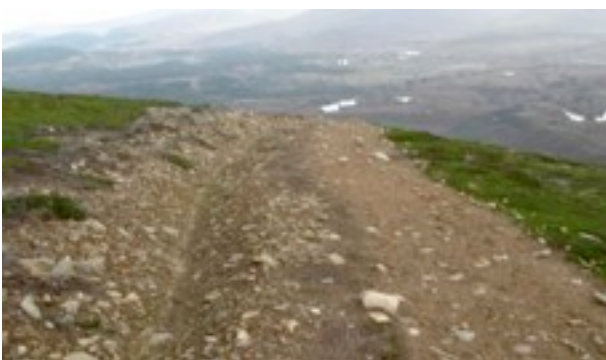
From the saddle to the summit of the Bhuachaille, the vegetation is more sparse with surface rock and loose stones. The former erosion scar has been successfully grass-seeded, using a mix of native grass seeds. This stands out against the heather, but it is a nurse crop and heather was seen to be colonising. A section of pitching on a slightly twisting route has been well contained by mounds of stones, but there is a danger elsewhere of loose stones on the path surface causing diversions on to relatively easy ground on either side, with consequential erosion. This is particularly the case close to the summit cairn.

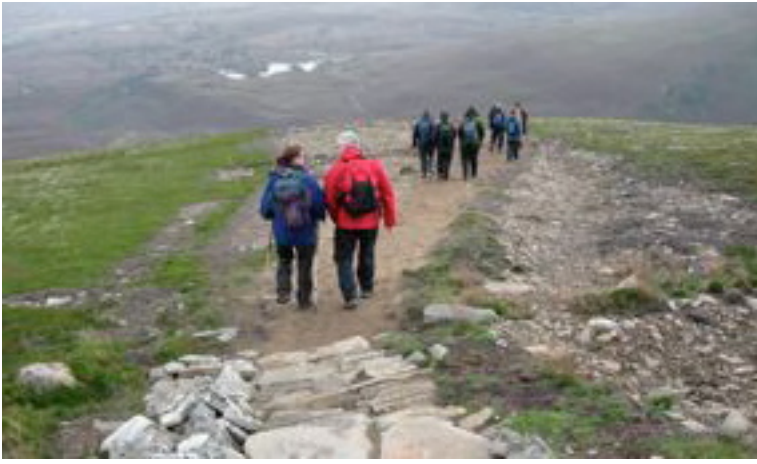
Descending from the summit towards Ryvoan, the path with the side slopes and wide topside ditch appears as a wide stony strip with only slow and sporadic regeneration. It seems there was no grass seeding here. There may be a case for an appropriate seed mix and 'Seed Aid' (degradable cellulose) to temporarily stabilise the surface as on Cairngorm.

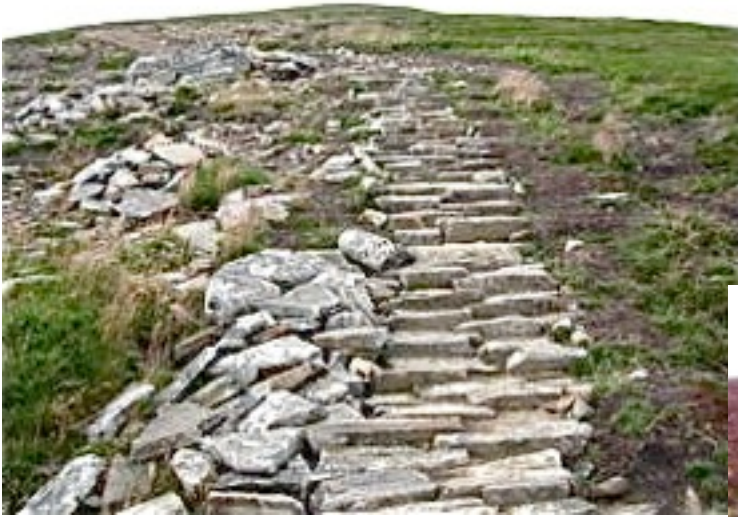
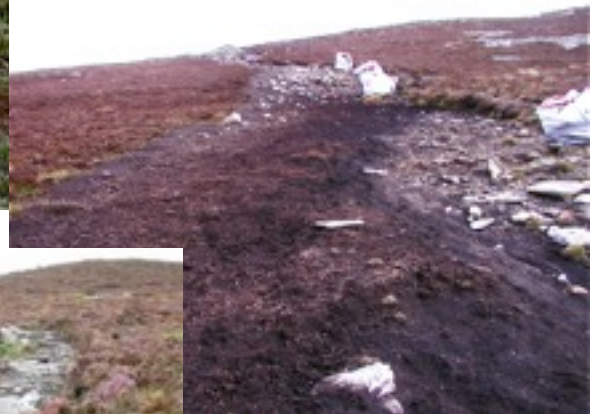
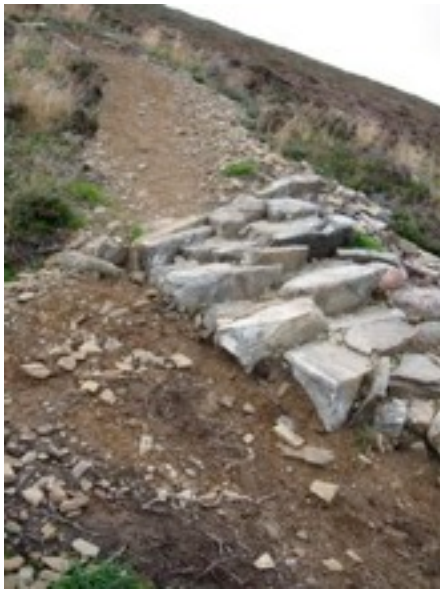
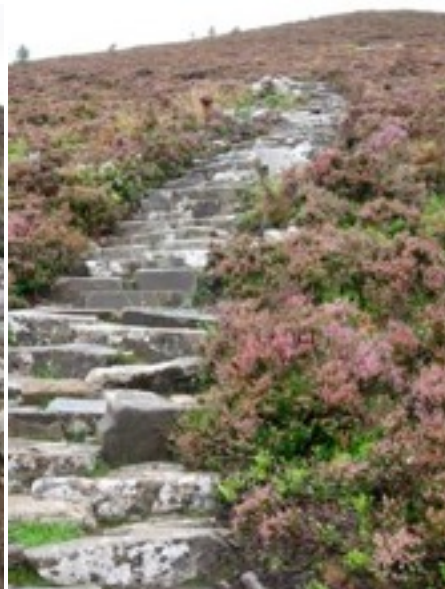
*Path under construction
-photo, Jim Gillies*

There was a problem of finding the best line for the path on the brow of the hill: there was a steep, wide erosion scar superseding a loop to the east (considered vulnerable to short-cutting) above a short craggy section. The new path was therefore swung to the west, after full planning consent was sought and granted by HC and CNPA, and designed to avoid an area of the lichen known as Alpine Sulphur Tresses.

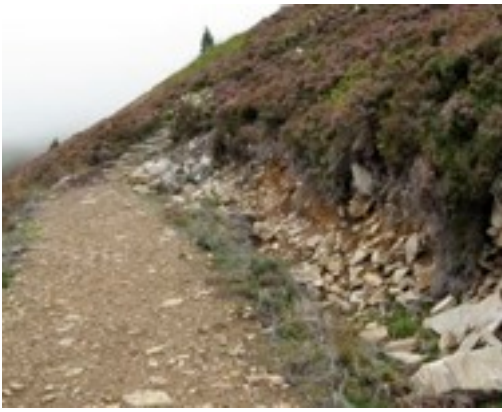
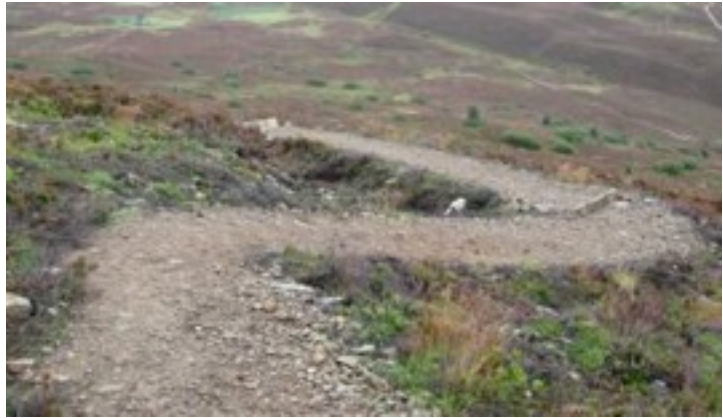
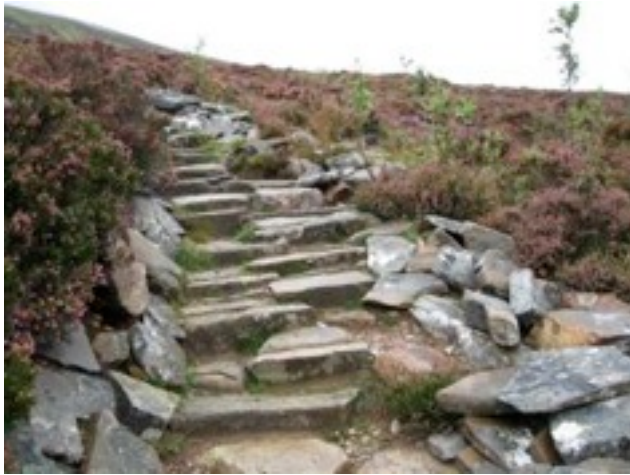
The path is then generally well-contained as it descends through deep turf and heather. There are 2 minor failures where steep sharp bends in the pitching have been avoided and these will

need remedial work. Notably there is a section of excellent but extraordinarily steep (30 degree) pitching. Below the pitching the path swings on a benched line across a slope so steep that the top side is overhanging and crumbling. Stabilisation is doubtful – some revetment walling could have been built here.

have had time to develop. Some remedial work is clearly needed; and maintenance extending beyond the clearing of drains should be imperative, including such work as clearing loose stones and using them for stone scatter on easier ground, and blocking incipient diversions. It is understood that the FCS forest craftsman is qualified for this.

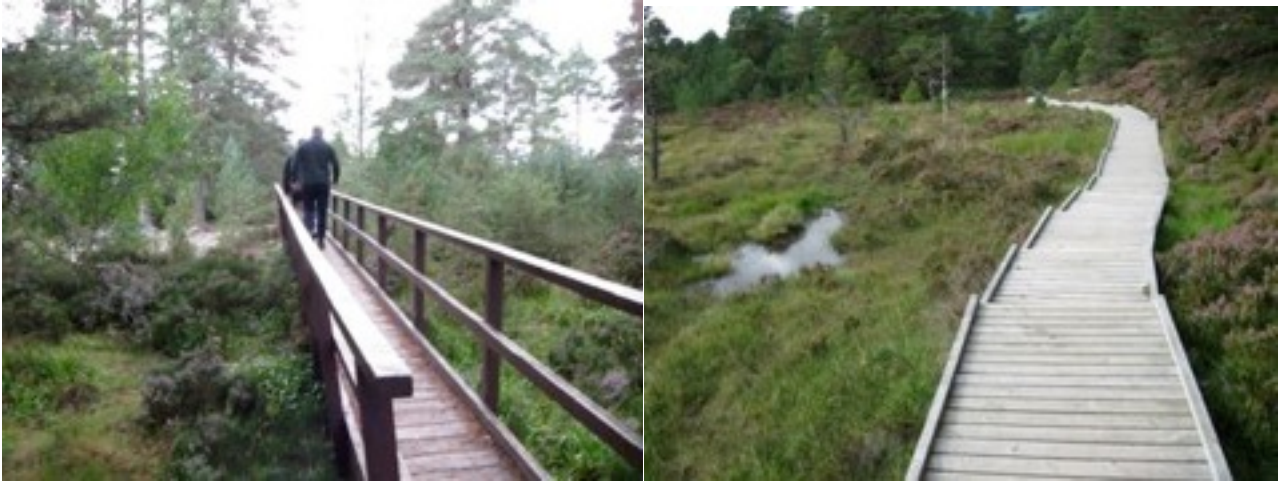
From the landscaped forest car park the path crosses the ski road (with warning signs) and soon after, a spectacular bridge of timber construction with side rails on an arching steel girder across the Allt Mor. (It is to be replaced by a wider bridge for DDA purposes at a cost of £30,000.) Then there is a right turn at a junction and shortly after, a timber slatted walkway 2 metres wide and 120 metres long, over the margins of a wetland area of biological interest. This construction fully preserves the hydrology of the area. Being pressure treated, the timber is considered maintenance free in the short and medium term, and the surface was surprisingly non-slippery. It does not look out of place in the wetland/ deep forest setting.

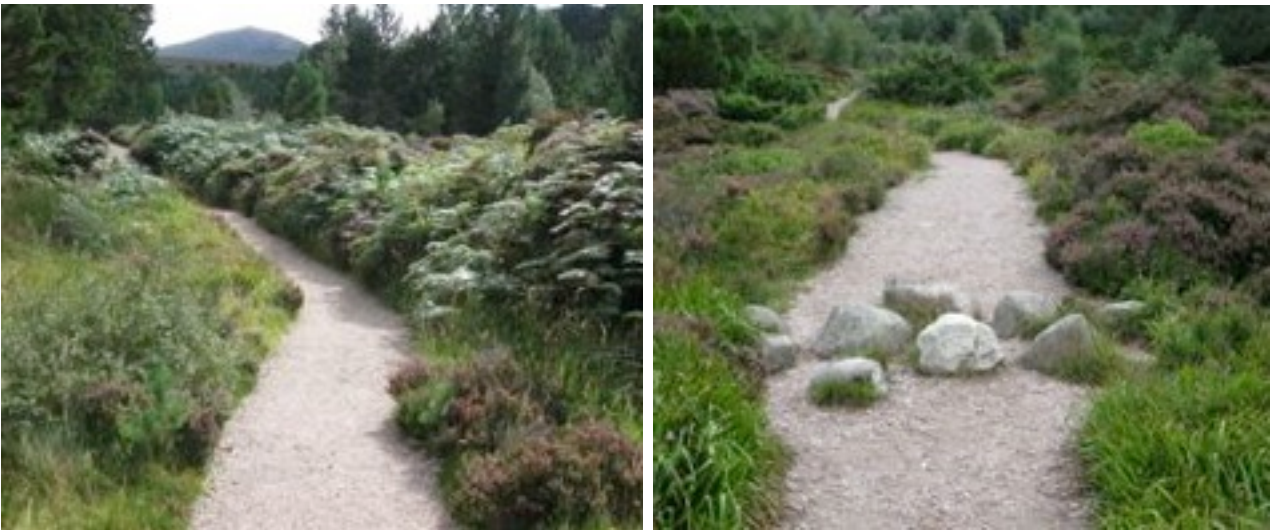
The path continues at low gradient on a slightly twisting route through mainly young pine, rowan, birch and juniper forest with deep heather and turf. Any temporary damage resulting from machine construction in 2002 has completely disappeared and the path is closely contained by robust vegetation – in fact some cutting back is needed.

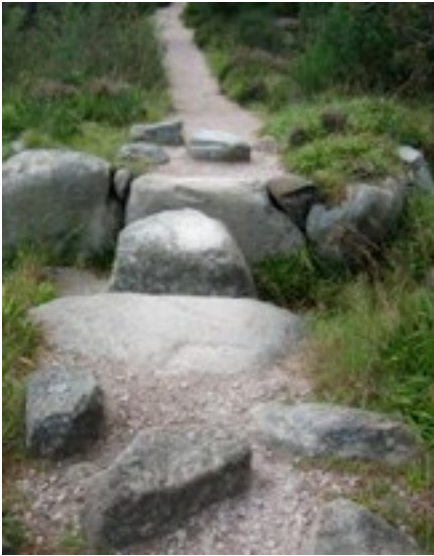
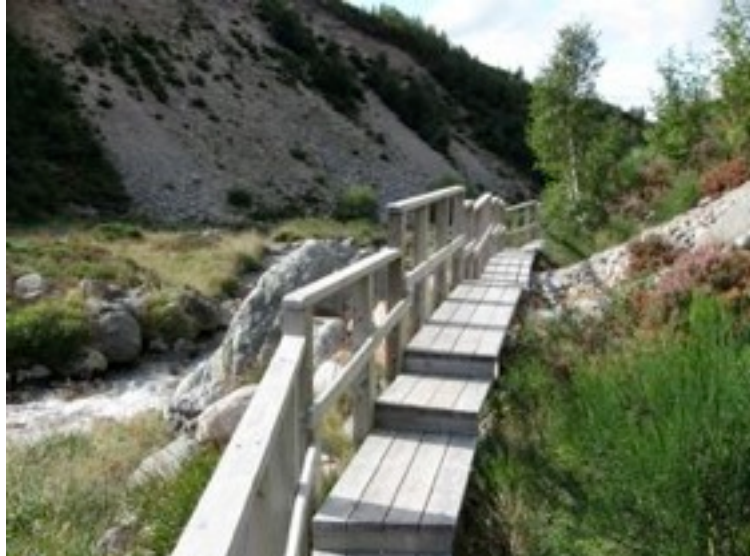
The visit concluded just beyond the footbridge at the start of the path to the Chalamain Gap, where there is a section of a walkway between the bouldery stream and the foot of a steep slope of unstable boulders. The walkway is 49 metres long and of similar construction to the walkway at the swamp, but narrower and with a handrail on the stream side. The pitching higher up was not inspected.
